Manhole Inspection Summary

Manhole # S49C__015MH

Insp Date: **6/11/08 1:12 PM**

Location Address: **rear 2600 e fairmount ave**

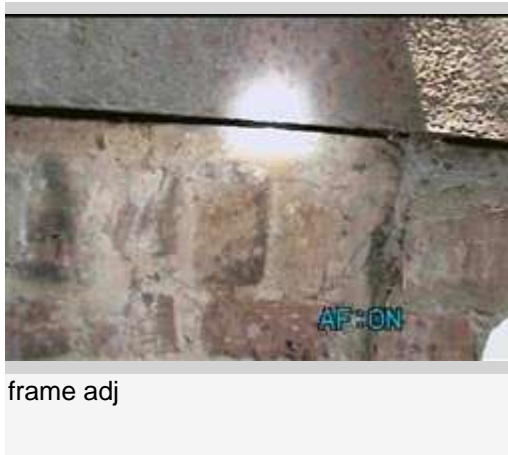
MISC

☒ Exists Material: **Brick and Concrete** ☐ Parged Height: **5** (in.)

frame adj

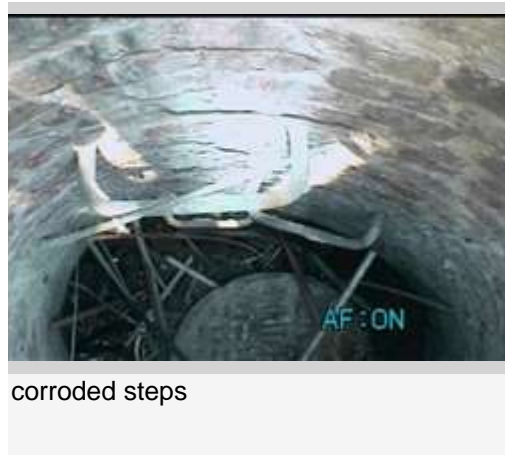
Defect 3

Count: **3** Missing: **0** ☒ **Corroded**

corroded steps

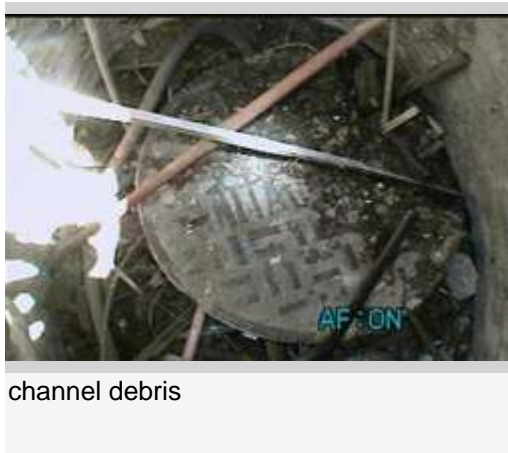
Defect 2

Condition: ☐ Sound ☐ Cracked ☐ Root Intrusion ☐ Deteriorated ☐ Leaks ☒ **Debris**

channel debris

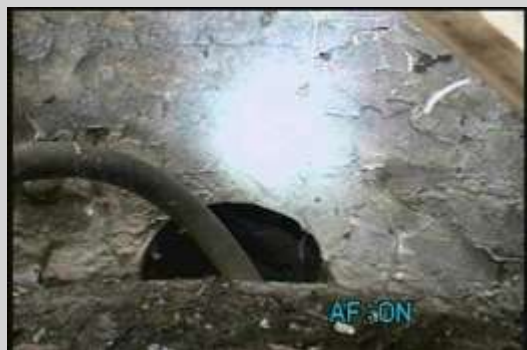
12 O'Clock Outflow

8 in. Circular Gravity Sewer
Pipe Out @ 12 O'Clock
